IMCA Safety Flash 15/13

September 2013

I LTI: Dropped Object Incident

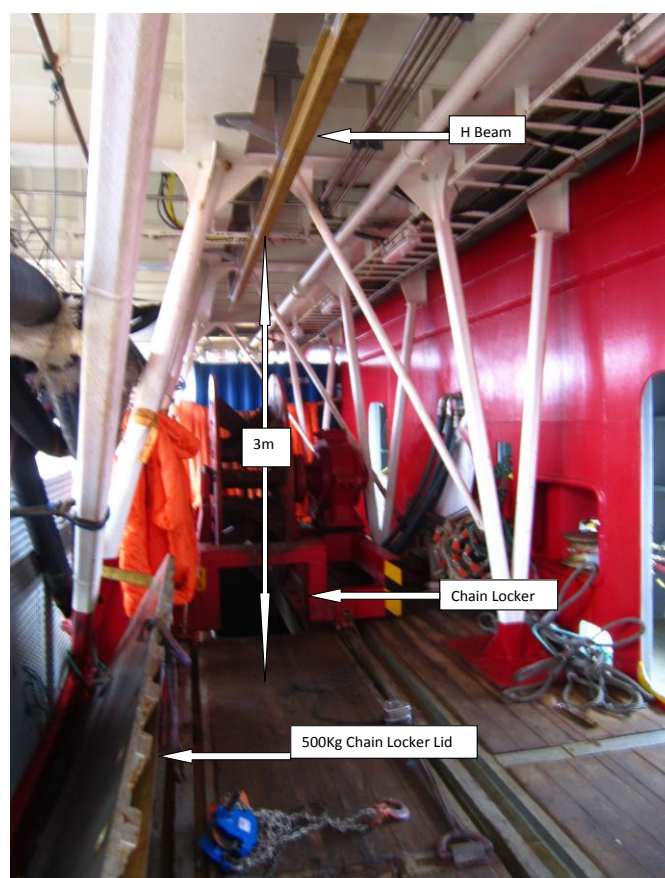
A member has reported an incident in which someone sustained a serious neck injury as a result of a dropped object incident. The incident occurred whilst members of the crew were using a chain block/tackle assembly on a H-beam, to assist with manoeuvring the heavy lids to the chain lockers which were located on a mezzanine deck. As chain locker lids are too heavy to move manually, two months previously, an H-beam had been installed in this location to permit the use of a chain assembly/trolley.

One of the persons conducting the work manually pulled the chain aside; momentum caused the trolley for the chain block assembly to run along the H-beam track. There was no end stopper and the trolley fell off the H-beam. It fell approximately 1.2 meters, glancing off the injured person's helmet and landing on deck. The total weight of the trolley and chain block assembly was approximately 33 kg. The injured person walked off the job unaided, and was attended by the onboard medic. The initial prognosis was a fractured neck. A neck brace was applied and then the injured party was medivaced by helicopter.

Figure 1 - General arrangement on mezzanine deck

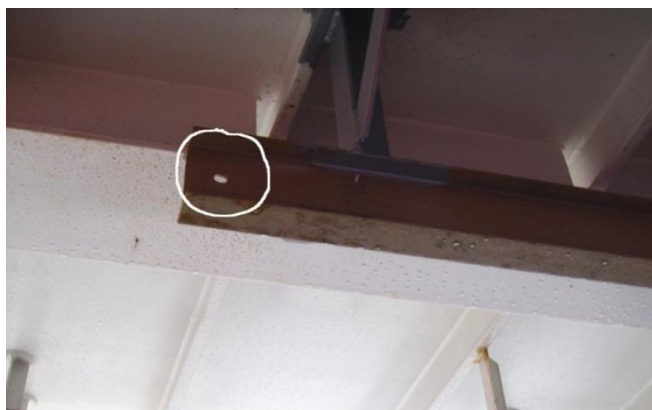
Figure 2 - H-beam with missing 'Trolley Stopper'

- ◆ There was no 'trolley stopper', or similar device, on the H-beam, to prevent chain assembly/trolley from falling off the end of the beam;
- ◆ The injured person was working under a unsecured load and ostensibly unaware of the consequences of pulling the chain assembly along H-beam when there was no trolley stopper;
- ◆ The injured person disconnected the chain from chain locker lid.

- Work equipment was allowed to be used, despite being known and identified as 'faulty'. The day before the incident it had been reported that there was no 'trolley stopper' on the retrofitted H-beam. No action was taken to address this very serious omission;

- ◆ Installed a trolley stopper on that particular H-beam;
- ◆ A fleet-wide "time out for safety" was carried out, and further DROPS awareness training was organised;
- ◆ A DROPS survey was performed with all similar beams inspected and maintained at member worksites;
- ◆ Checked certifications of H-beam, lifting equipment and chain assembly requested for inspection.

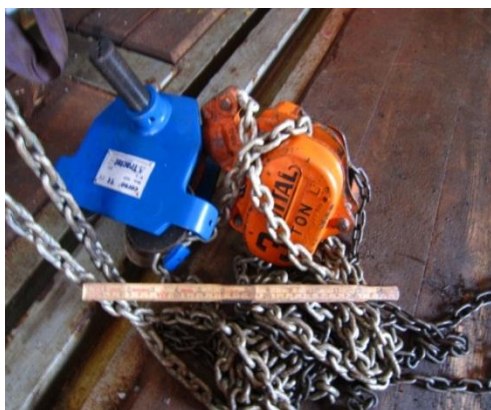
Figure 3 - Chain Assembly

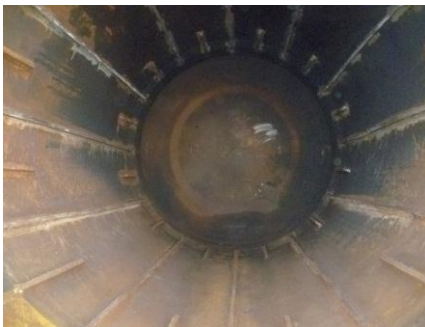
Incident #1 - after a test blow of a hydraulic hammer, it was discovered that a scaffold pipe was damaged between the anvil and the casing.

Immediate cause: Although the site was inspected, the hazards were not recognised.

Scaffold pipe hits anvil of hydraulic hammer

- ◆ Perform a full workplace risk assessment before starting the work;
- ◆ Keep walkways clear of obstacles, or otherwise mark obstacles;
- ◆ Never modify scaffolding;
- ◆ Remove all scaffolding material after the job, and contact scaffolding supervisor when scaffolding material is left behind.

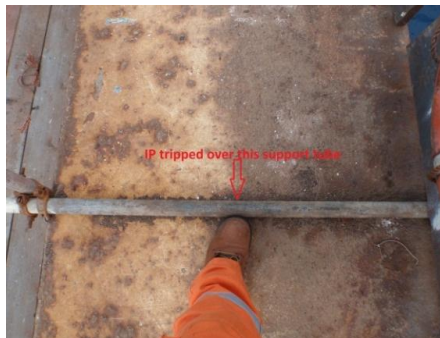
Incident #2 - a crewman was injured after tripping over a scaffold tube (supporting the handrail) whilst carrying an angle bar of approximately 15 kg.

Immediate causes: Poor co-ordination of the work activities, and there was no signage in place to warn of the obstacles.

Tripping over scaffold board

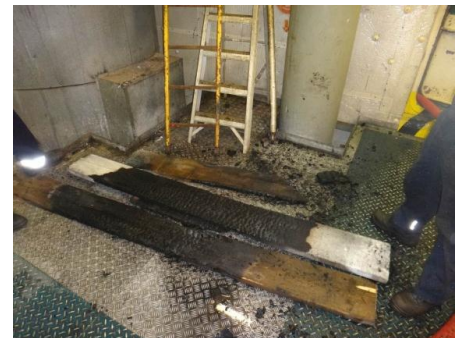
Incident #4 - scaffolding boards, which were out of sight, on top of the exhaust line, were left over from repair works and started to smoulder due to the heat of the exhaust line.

Immediate cause: Improper housekeeping after work was finished.

Smouldering scaffold boards

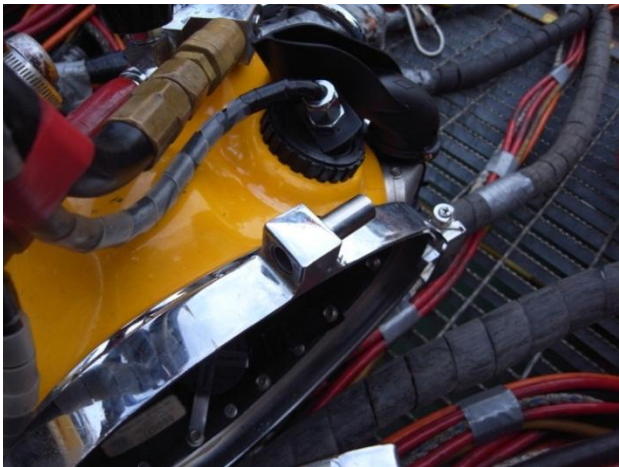
A member has reported an incident without injury in which the knob of a sealed pull pin assembly (p/n 505-110) on a Kirby Morgan diver's helmet came apart. The incident occurred after an air dive, when the dive team was assisting the diver to remove his helmet. On the block side of the hat, the sealed pull pin came apart whilst undressing the diver. Upon inspection, the dive team found that the threaded part of the shaft on the plunger, at the base of the threading, just above the square key, had broken and the knob had separated from the pull pin assembly. The Nyloc lock nut was connected to the top threaded section and still in the end of the knob. All parts of the pull pin assembly were recovered. Both sealed pull pin assemblies on the helmet were removed and replaced.

Our member contacted Dive Lab to discuss the incident. From photographs and information sent by our member, it was determined that the pull pin shaft had crevice corrosion.

Helmet sealed pull pin slot after failure

- ◆ Pre- and post-dive checks;
- ◆ Regular careful inspection of pull pin assemblies, in accordance with Dive Lab checklist appendices A2.1, A2.2 and A2.23;
- ◆ Regular check of pull pins for signs of leakage and corrosion, and to ensure that pull pins are operating properly;
- ◆ All torque specifications for fasteners (10-15 inch/lbs for the Nyloc Lock Nut on the pull Pin assemblies) should be strictly followed.

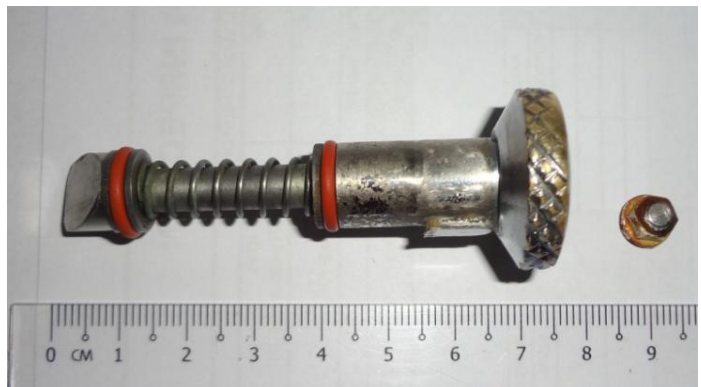
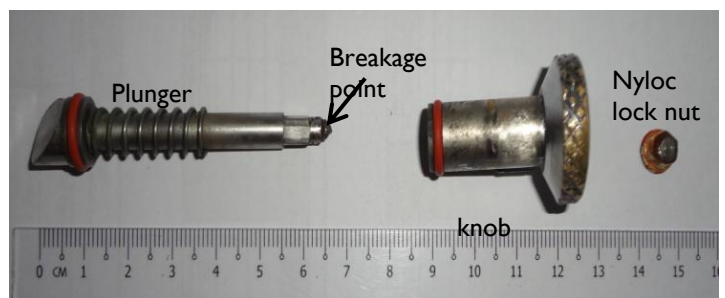
Parts of failed sealed pull pin
