IMCA Safety Flash 28/17

November 2017

1 KM 37k/ss Helmet Neck Dam Near Miss

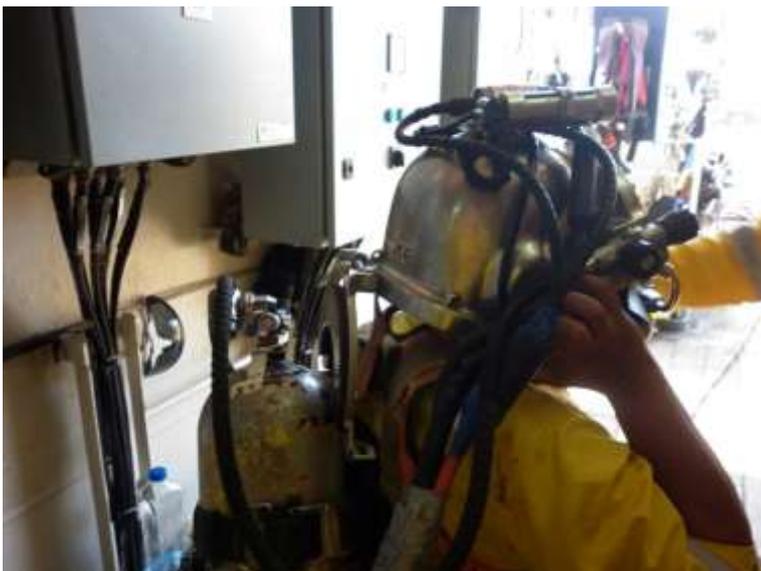
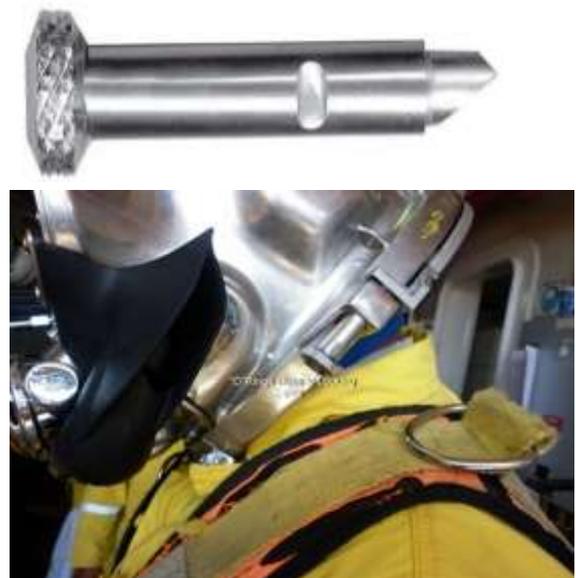
Photo indicates the open locking collar assembly in open position, behind diver's shoulders

Upon investigation of the dive video and audio recordings, it was identified that at some point during diving operations the knurled end of both helmet locking pull pins, used to secure the locking collar assembly (*see photo*) had caught on top of the R-Vest shoulder harness at the attachment D-ring “where the inspection equipment (CP-UT meter) are secured via a rope lanyard”. This had pulled the locking pins, thus resulting in the locking mechanism coming open. As a result, the locking collar assembly opened and dropped past the diver’s shoulders removing the primary guard that holds the helmet on the diver’s head.

Just before the event the diver is heard to flush the helmet via the free flow. This slight over-pressurisation caused the inner neck dam ring to pop out of the helmet outer neck dam ring. When the free flow was stopped water could flood into the helmet.

- ◆ The **direct cause** was found to be:
 - The knurled end of both helmet locking pull pins that secure the hinged locking collar assembly (*see above photo*) had caught on top of the R-Vest shoulder harness and pulled to open position;

- ◆ The underlying **root causes** were found to be:
 - The swing hinged locking collar assembly dropped to an open position whilst the diver was working, without him noticing, and passed the top of his shoulders as he leaned forward to conduct tasks

- Activation of helmet free flow to help demist the visor caused a slight over-pressurisation inside the helmet resulting in the neck dam O-ring popping open. This allowed water to enter the helmet when free flow was turned off;

- ◆ **Root causal factors** identified were:
 - Design failure of the locking pull pins was not addressed during helmet maintenance which recommended fitting of KM *Pull Pin Sleeve Kit* part #525-112.

- ◆ Helmets should have been maintained and modified to address previously identified findings in the IMCA safety flash 20/16 issued in August 2016;
- ◆ Kirby Morgan Dive Systems Inc have addressed the potential issue by developing a *Pull Pin Sleeve Kit* part #525-112 (*see image to right*). This device helps reduce the possibility of pins been inadvertently operated. They were not fitted to the equipment involved.

- ◆ All helmets returned to workshop for fitting of KM *Pull Pin Sleeve Kits*;
- ◆ Divers given familiarisation brief of with potential hazard;
- ◆ Dive tenders reminded of the need to follow pre-dive dressing procedures, ensuring the neck dam is locked and secure and recording that this check has taken place;
- ◆ To prevent recurrence, divers and tenders were instructed to be vigilant regarding items that could cause or interfere with the pull pins;
- ◆ The practice of hanging work tools on the upper part of D-ring on recovery harness will be stopped.

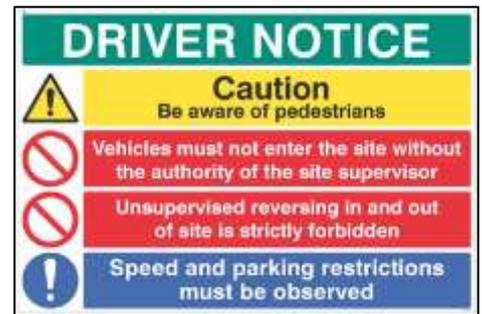
The UK Health & Safety Executive (HSE) has prosecuted a road haulage firm after an employee was crushed between two articulated vehicles and subsequently died from his injuries. A driver suffered fatal injuries when his vehicle rolled forward out of control whilst he was coupling the HGV (heavy goods vehicle) tractor unit to a trailer. See [here](#) for original press release.

UK HSE investigation found that the company had failed to implement safe systems of work or monitoring arrangements to ensure that its drivers were consistently undertaking coupling and uncoupling operations safely, in line with widely available industry guidance. As a result of this, a culture developed whereby its drivers were not always applying trailer parking brakes.

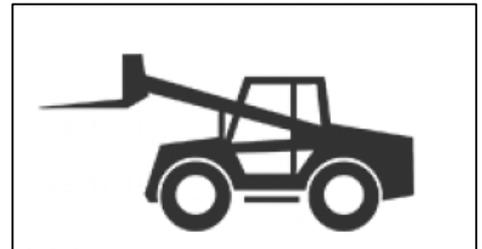
A worker was struck by a reversing telehandler when crossing the work yard. The worker sustained multiple injuries and later died in hospital. See [here](#) for original press release.

- ◆ The company had failed to address the management of large vehicle movements on its site;
- ◆ The company had not carried out an on-site health and safety inspection;
- ◆ The driver of the telehandler involved in the incident had not received any training in operating this vehicle.

This was a wholly avoidable incident, caused by the failure of the company and its director to take simple steps. Vehicle movements...were not controlled even at a basic level at this company's site. The company failed to have adequate pedestrian segregation measures such as walkways or crossing points in areas where pedestrians walked routinely. Reversing of large vehicles near to pedestrians was commonplace. This was a dangerous mix which led to this tragic incident.

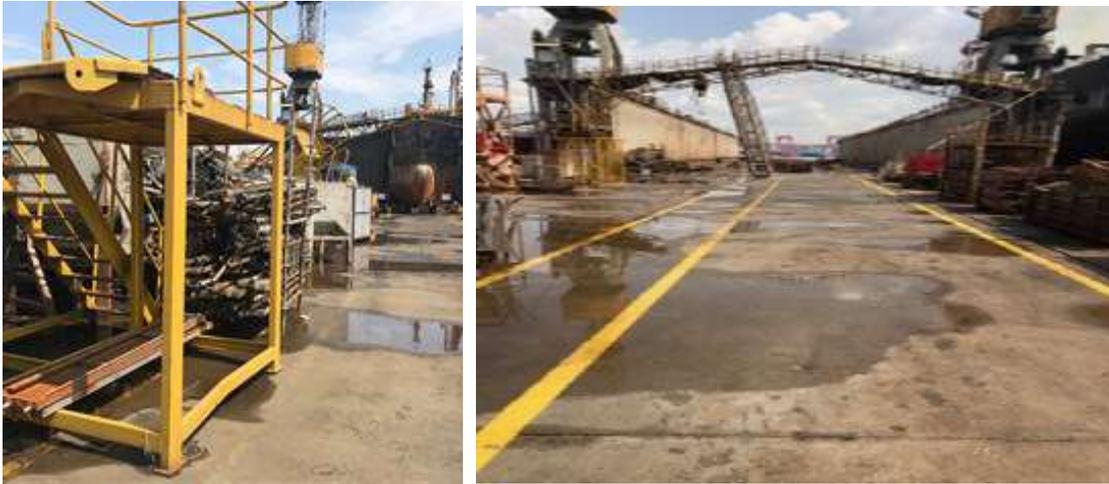
A member reports a near miss incident in which a worker was almost hit by a 'cherry picker' mobile crane. Whilst walking to a dry dock, a shipyard visitor was almost struck by the vehicle when it suddenly reversed driving direction.

- ◆ The cherry picker operator did not look first before reversing;
- ◆ There was inadequate traffic management or separation zones: the pedestrian walkways were not clearly visible as the paint markings had faded away;
- ◆ The traffic separation scheme for equipment and pedestrians had been blocked off with the storage of materials.

- ◆ Further toolbox talks for all equipment operators to address safe work practices;
- ◆ All materials blocking the pedestrian walkway were removed;
- ◆ Traffic separation scheme marking were refreshed with a new coat of paint.

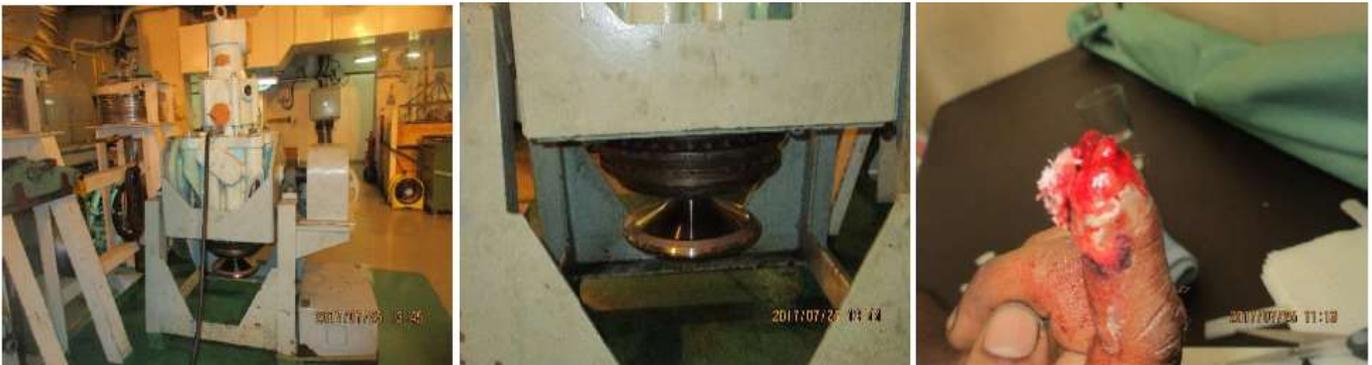
An engineer suffered a crushed finger when there was an unplanned movement of a main engine exhaust valve during maintenance. The second engineer and a fitter were working together on the overhaul of a main engine exhaust valve. After completion, the valve was tested with compressed air. Once the air was shut off and the seat descended, the second engineer noticed some dirt on the face of the seat. He instructed the fitter to stand clear using hand signals, and attempted to clean the dirt with a rag. At that moment, the fitter opened the air and the seat face moved upwards, crushing the second engineer's finger as he attempted to remove his hand.

- ◆ Some of the **immediate causes** were found to be:
 - Poor communication: Although in plain sight of each other, the noise of the engine room meant that verbal communication was not possible between the second engineer and the fitter. The fitter didn't see or understand the hand signals from the second engineer, and the reopening of the valve was not communicated to the second engineer

- Hand placed in dangerous position "in the line of fire"
 - Following the successful test of the overhauled valve, the compressed air was not disconnected prior to second engineer cleaning the face – crew were servicing equipment that was still in operation

- Inadequate planning – there was a failure to disconnect the compressed air prior to cleaning the face
 - Hazardous environmental condition – noisy engine room;

- ◆ The **root causes** were found to be:
 - There was no adequate system of communication and confirmation during operations in noisy environment was not identified during risk assessment neither discussed in toolbox talk

- There was no isolation (lockout/tagout)
 - Inadequate compliance – the risk in this routine, recurring task was seen as tolerable.

- ◆ Develop method of communications in noisy work environment and ensure this is included in risk assessment;
- ◆ Review/familiarisation of crew on company lockout/tagout procedures.

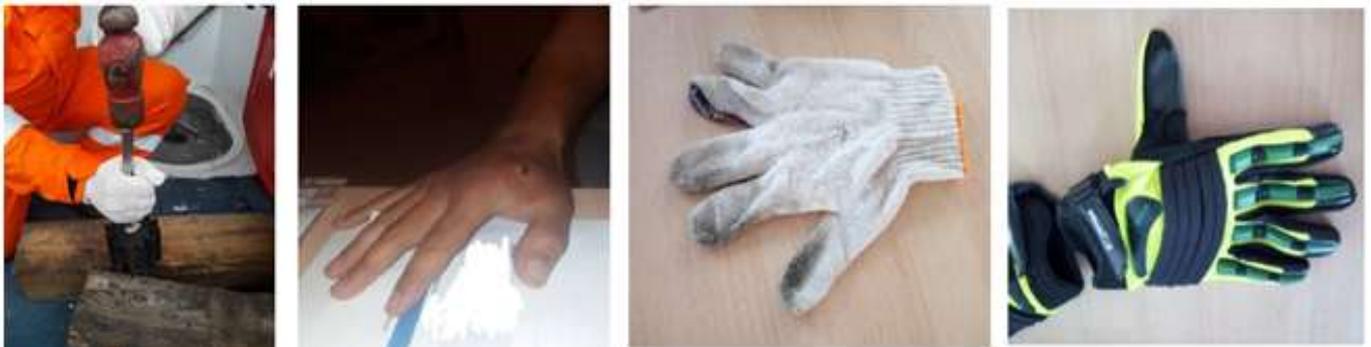
A crewman attempted to remove the impeller from a fire pump using a hammer and punching rod. While he was hammering, a steel splinter of the punching rod (3-4 mm) chipped off and punctured his right hand.

The incident happened during corrective maintenance to a fire pump. The injured person was tasked by the Chief Engineer to disassemble the pump, as the Chief was busy with other work. The injured person observed that the impeller was stuck on its shaft due to misaligned splines between impeller and shaft. He started to attempt removal of the impeller by knocking out the shaft using a hammer and a steel punching rod. The punching rod splintered and the splinter went through the injured person's glove and entered the soft tissues between thumb and index finger.

- ◆ The tools selected for the job were inadequate;
- ◆ An adequate and correct gear puller specially designed for the task was not available on board;
- ◆ Inadequate hand protection equipment was used for the task; cotton gloves were used instead of mechanical impact protection gloves, which were available onboard.

- ◆ Ensure the right tools to do the job are available;
- ◆ Proper PPE, whilst a last line of defence, can minimise consequences or prevent injuries from happening.
