IMCA Safety Flash 02/11

February 2011

3 Service Bulletin

SUBJECT	:	recommended exchange previous CCU version
ENGINE TYPE	:	all
EQUIPMENT	:	Integrated Flywheel Generator (IFG) regulator
VERSION	:	24VDC
DATE	:	September 28, 2010
SB No	:	SB2010IWP091

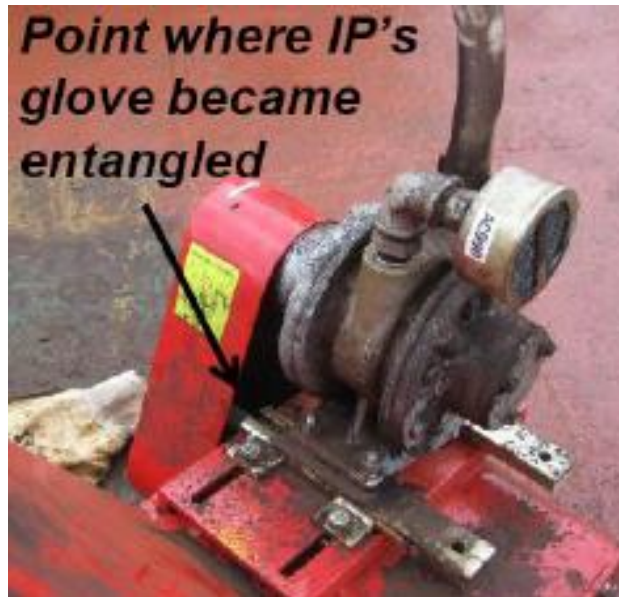
Figures – Deck scaling machine showing where person's glove was caught

- ◆ The deck scaling machine had no 'dead man' type control;
- ◆ The physical barrier to injury offered by the installed guards on the deck scaler was defeated;
- ◆ Existing company procedures for the use of this air-driven device clearly state 'disconnect airline before any trouble shooting or maintenance'.

- ◆ A design deficiency in the deck scaling machine;
- ◆ Failure to follow basic safe working practices.

- ◆ Further use of machines of this type was prevented until the suitability of appropriate control measures could be demonstrated. These included 'hard' barriers such as guarding and a dead man switch, and 'soft' barriers such as risk assessment and operating instructions;
- ◆ Further equipment was identified which may present a similar risk (guarding/dead man switch) i.e. drilling machines, lathes, bench grinders, etc. and actions identified which would appropriately manage the risk.

The manufacturer of the deck scaler was contacted to feedback concerns and highlight the lack of a 'dead man' switch on the device, and a swift and positive response was received from the manufacturer.
