## IMCA Safety Flash 06/07

July 2007

### 1 Diver Injury Using Cavitation Blaster

### 2 Weld Failure on Kirby Morgan KMI7B 505-055 Neck Clamp

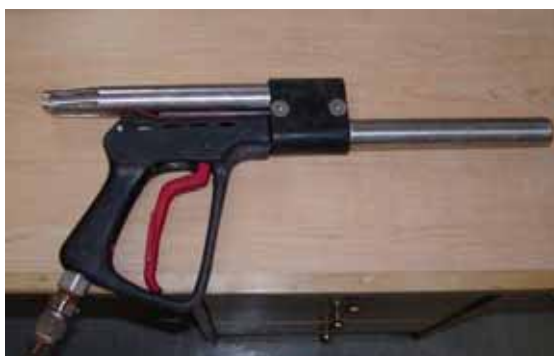
*Cavitation gun*

During marine growth removal operations the diver released the trigger on the cavitation gun to reposition his body. When the diver reapplied pressure to the trigger, the cavitation gun kicked back towards the diver, causing the retro end of the gun to come into close proximity of his wrist and forearm. The retro jet subsequently caused a high pressure (approximately 1000 psi) seawater injection injury to the diver's forearm.

The risk assessment had not highlighted the fact that the retro jet posed a high pressure injection risk to the diver.

The incident investigation discovered that the diver had not been wearing the 11 inch long butyl rubber gloves as recommended by the system manufacturer but it was unclear if wearing these would have prevented the injury.

The manufacturer has now modified the retro jet by moving the nozzle further back inside the rear baffle. The company involved will be carrying out a full examination of the modification before allowing the cavitation blaster back into use.

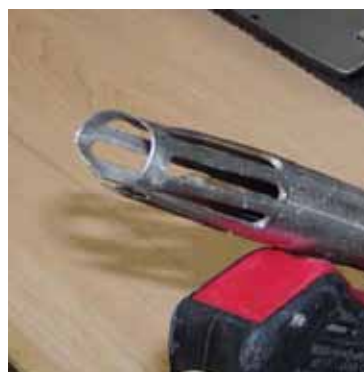
*Retro jet showing proximity of nozzle to end of baffle (approx 3 cm)*

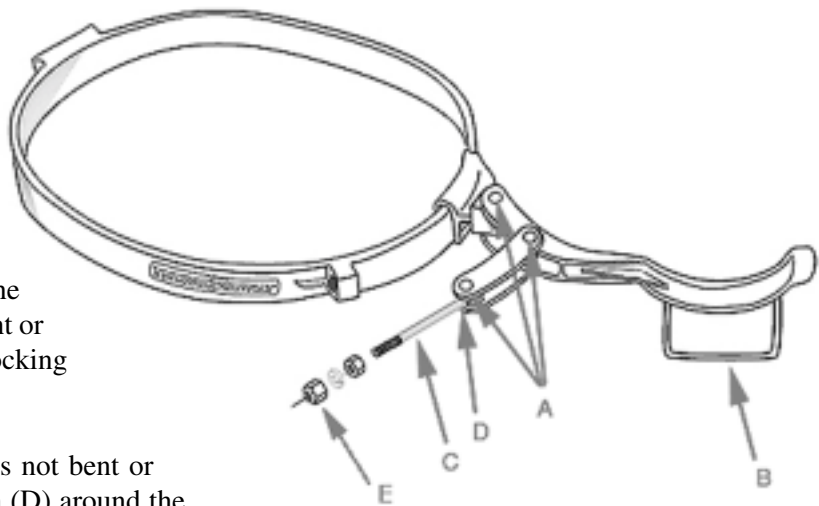
Visually inspect the moving parts of the clamp assembly including the three pins (A) in the over-center lever assembly, and the three clevis blocks. Visually inspect for bent or broken pins or a bent or broken handle and locking bail (B).

Check to ensure the adjustment stud (C) is not bent or damaged. Visually inspect the welded area (D) around the base of the stud for signs of stress or weld cracking.

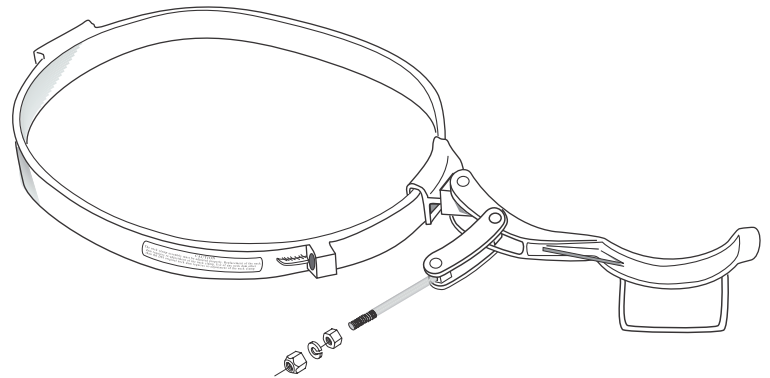
Kirby Morgan Dive Systems, Inc. (KMDSI) was alerted by its Authorized Dealer in Southern Africa about the following incident: A Kirby Morgan SuperLite 17A/B (Serial #82929, purchased in April 1997) neck clamp assembly was found jammed in a container door. The neck clamp was hanging on the umbilical rack on the door and the person closing the container door did not notice that it was jammed. When the jammed neck clamp was discovered, it was removed and closely inspected.

During the clamping process (onto the helmet) one of the welded pins on the neck clamp assembly broke off. On closer inspection it was noted that there was no way of identifying this potential break as both sides of the pin are welded.

It is important that a visual inspection of the neck clamp assembly be done before every dive. Normal inspection of the neck clamp assembly is covered in the Kirby Morgan Daily Pre-Dive inspection Appendixes A2.3, Monthly Inspection A2.2 and the Annual / 400 Hour Overhaul A2.1. These Appendixes can be found at <<http://www.kirbymorgan.com/>>www.kirbymorgan.com under notices/maintenance checklists.
