## IMCA Safety Flash 06/07

July 2007

### 1 Diver Injury Using Cavitation Blaster

### 2 Weld Failure on Kirby Morgan KMI7B 505-055 Neck Clamp

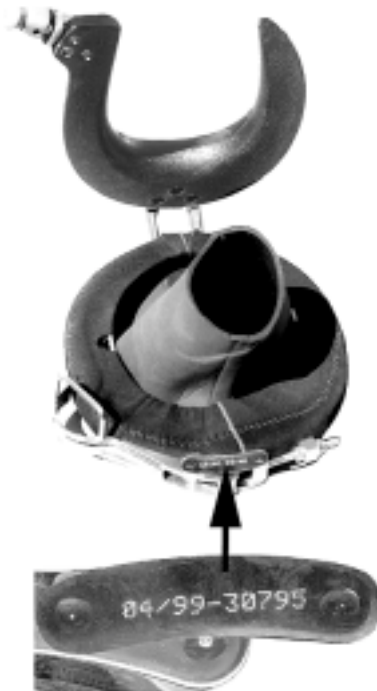
Visually inspect the moving parts of the clamp assembly including the three pins (A) in the over-center lever assembly, and the three clevis blocks. Visually inspect for bent or broken pins or a bent or broken handle and locking bail (B).

Check to ensure the adjustment stud (C) is not bent or damaged. Visually inspect the welded area (D) around the base of the stud for signs of stress or weld cracking.

Check to make sure the rear hinge tab is secured tightly to the clamp foundation. This can be checked by wiggling the yoke back and forth sideways (M) to ensure it and the hinge are securely tightened to the hinge tab and the hinge tab is secured to the clamp. If there is a slop in this movement, first check to ensure the brass hinge is firmly attached to the yoke assembly (2) and the two bolts (3) are installed securely to the brass hinge. If these are tight, the hinge tab to clamp screws may be loose. To tighten these screws you must remove the two bolts (3) holding the brass hinge to the clamp and remove the yoke & hinge from the clamp. The screws may be accessed by pushing the neck dam neoprene (4) to the side. After tightening the screws, remount the yoke & hinge using the two bolts. You must use Loctite® on the bolts (3) when reinstalling them.
